FOR A QUIET LIFE... CALL THE EXPERTS

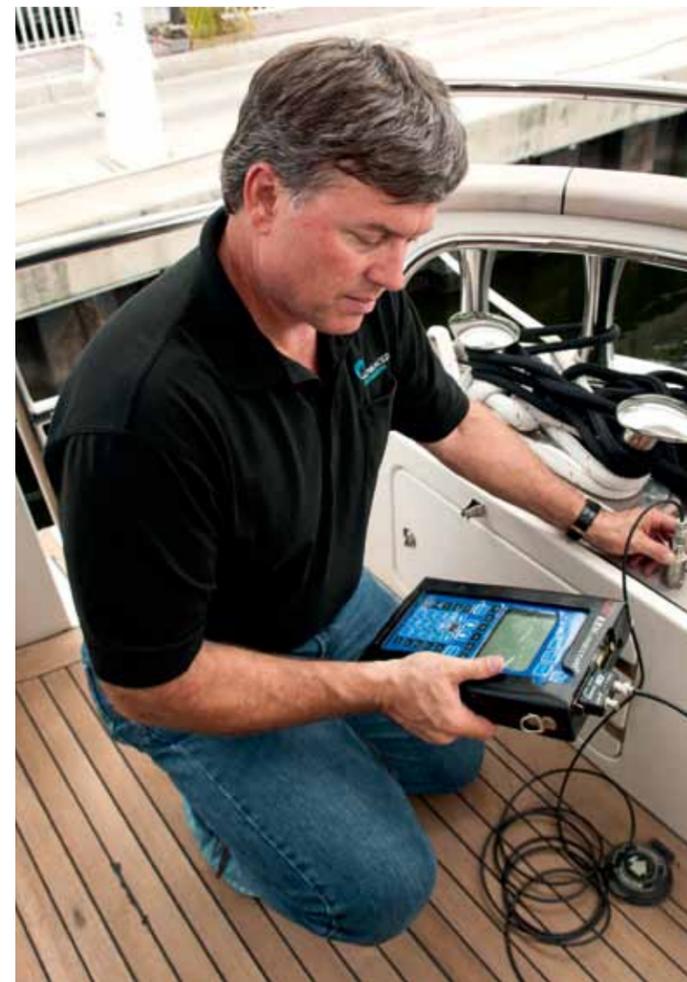
Checks are made for machinery vibration being transmitted through the hull (left), and the Rotalign Ultra unit is fitted to a Cardan shaft (above)

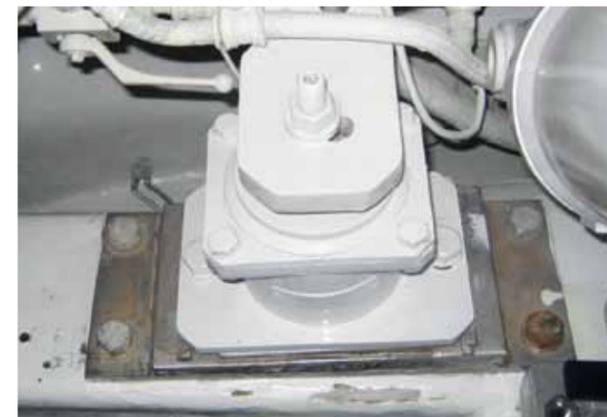
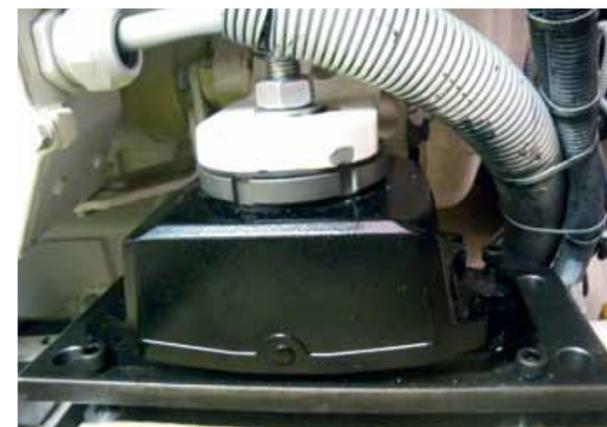
The yacht's original engine mounts (above left) were replaced with Rubber Design TT3 mounts (left)

extension (+), necessary to maintain the optimum isolation properties of the mass-spring system formed by the engine, gearbox and mountings. When the engine alignment was confirmed, ChockFast Orange epoxy was used to set the new mounts in place. High-tech vibration monitoring equipment was then used to sea-trial the vessel and record baseline data which can be used to diagnose any future problems.

gearbox with a computerised laser. This was done in conjunction with the replacement of the engine mounts with improved ones that provide more isolation, thereby increasing the stability of the engine while reducing vibration transmitted to the hull. These new Thrust Torque (TT) mounts by Dutch manufacturer Rubber Design were chosen with the help of the company's US distributor, Soundown, based on the mass and excitation vibration frequencies of the engine. They have a linear stiffness over a wide load range varying from compression (-) to
